PROTECTION OF MOORING  
BUOYS - PART V. FOURTH  
RATING INSPECTION

4 January 1965

U. S. NAVAL CIVIL ENGINEERING LABORATORY  
Port Hueneme, California

R. W. Drisko, Ph D

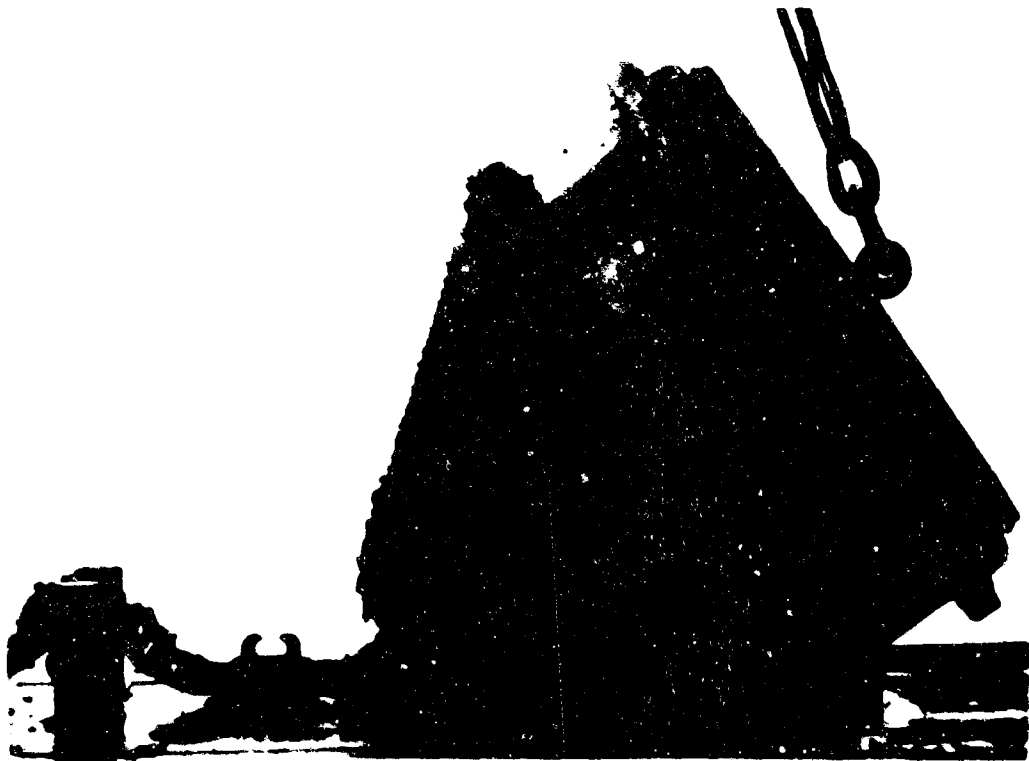
The buoy with Coating System 3 was in essentially the same condition (Figure 4) as at the previous inspection. The yellow epoxy primer was continuing to protect the steel from corrosion in areas where much of the polyester topcoat had been lost. The side of the buoy was considerably streaked with rust from behind tack-welded flanges and from abraded areas.

Figure 4. System 3 buoy after removal of fouling.

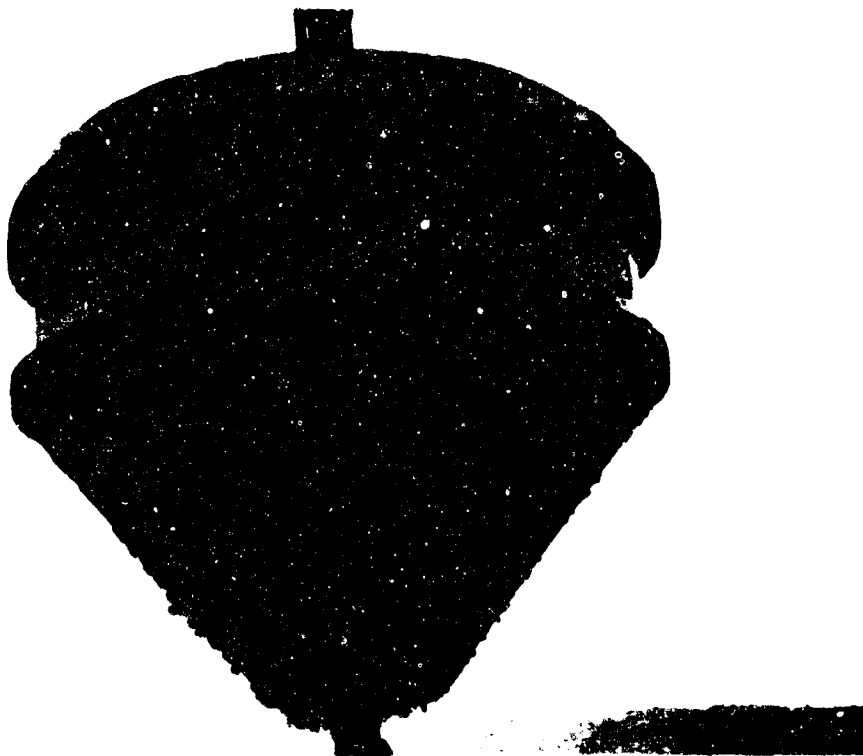
The buoy with Coating System 4 was in essentially the same condition (Figure 5) as at the previous inspection. The delamination of the topcoat and seal coat (Figure 6) had increased only slightly, and the underlying epoxy primer and coal tar epoxy were providing good protection to the steel.

Figure 5. System 4 buoy after removal of fouling.

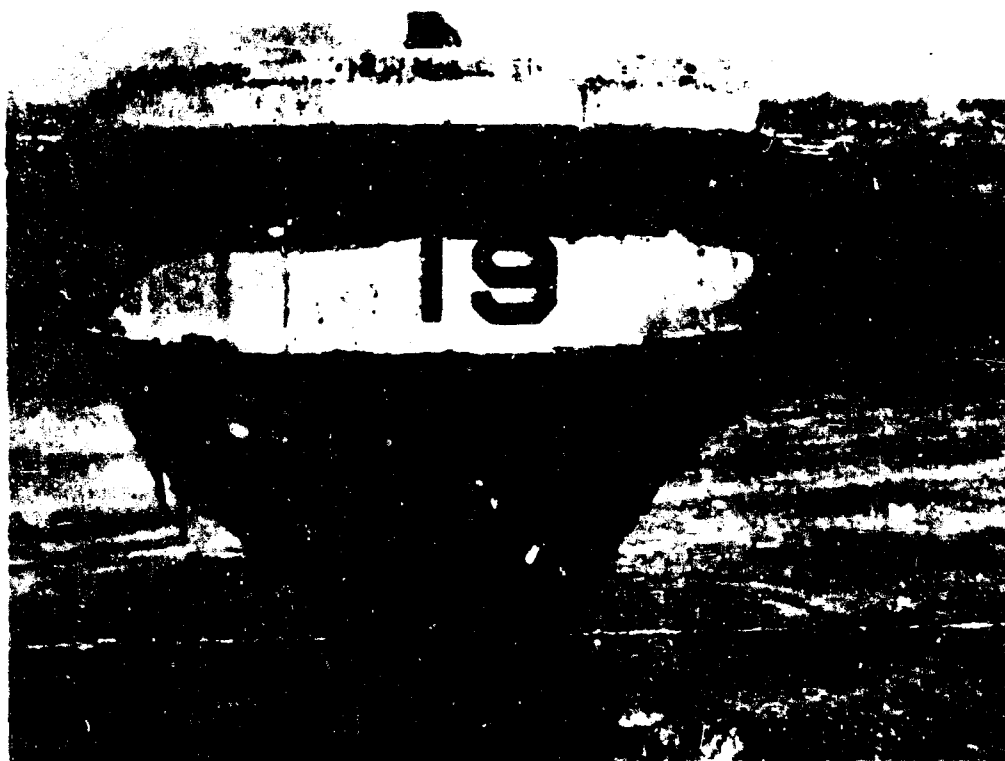
The fouling on the Coating System 7C buoy (Figure 10) was of a type and intensity similar to that on test buoys without antifouling paint. Growths of barnacles and tunicates were relatively heavy, and there were mussels, hydroids, green algae, and tube worms to a lesser degree. The yellow primer had been exposed in many places on the submerged portion of the buoy where the antifouling paint had eroded, but this had not permitted any rusting. The pin-point rusting previously noted<sup>4</sup> in the atmospheric and splash zones had not advanced significantly since the previous inspection.

Figure 10. System 7C buoy before removal of fouling.

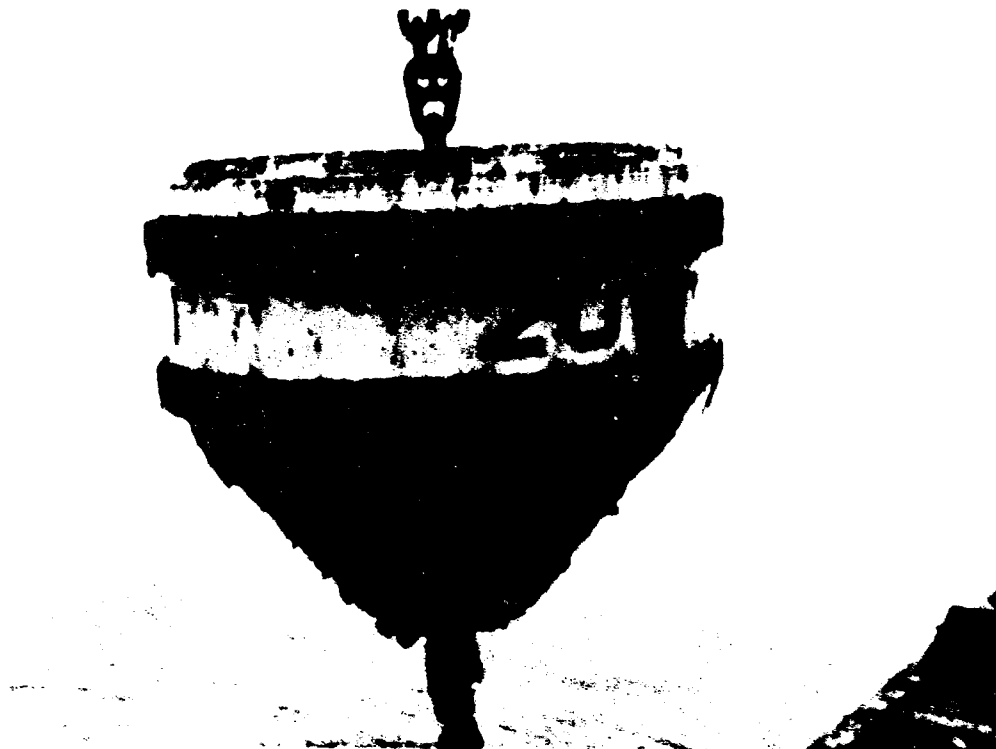
The coating system on the submerged portion of the System 8 buoy (Figure 11) was identical to that of the System 7C buoy. Consequently, the fouling on both buoys was similar. The System 8 buoy, however, had lost less antifouling coat, so less yellow primer was exposed. The pin-point rusting and abraded areas previously noted on the buoy<sup>3,4</sup> showed no further significant corrosion since the previous inspection.

Figure 11. System 8 buoy before removal of fouling.

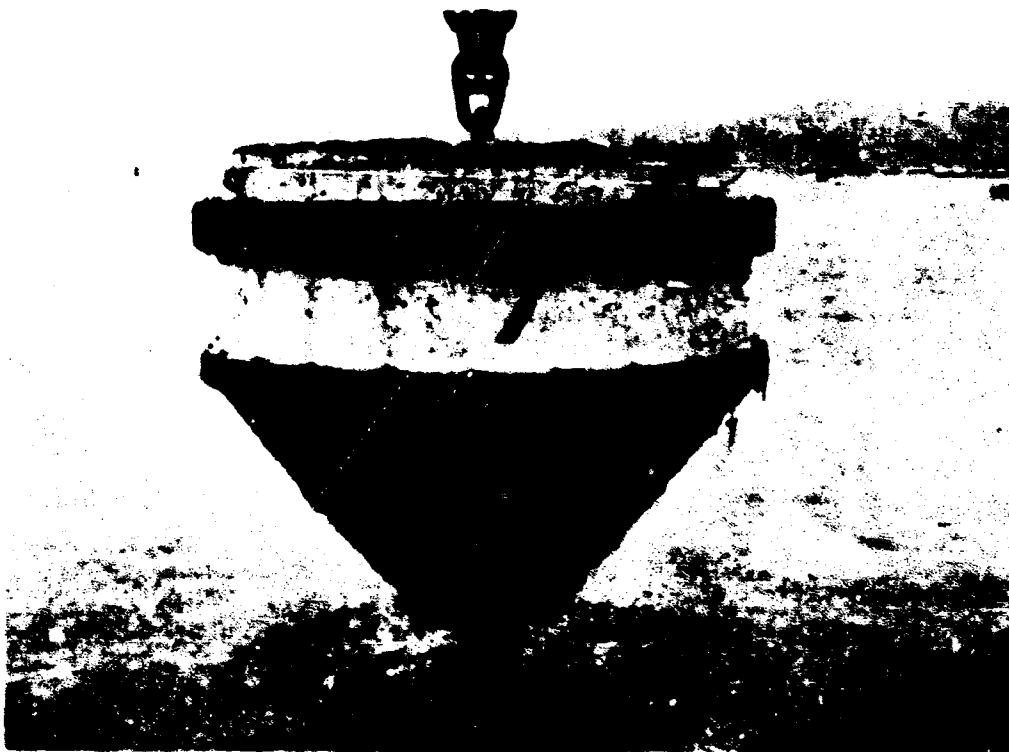
The Coating System 12 buoy was essentially free of corrosion in all three zones (Figure 14). The only corrosion noted was where portions of the top edge had been abraded by mooring lines. Although approximately half of the primer and topcoat had been lost from the submerged portion of the buoy after 6 months of service, the underlying inorganic zinc silicate was still preventing corrosion 18 months later (Figure 15).

Figure 14. System 12 buoy before removal of fouling.

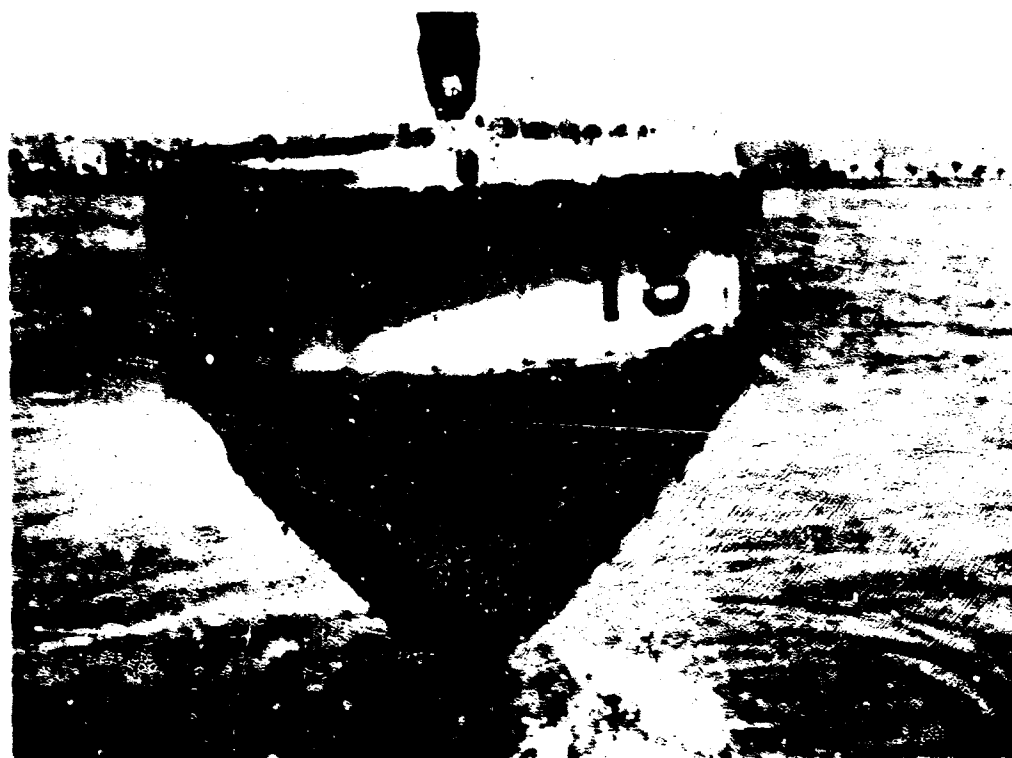
Coating Systems 13 and 13C were identical, but System 13C was applied to a cathodically protected buoy. There was rust on both buoys (Figures 16 and 17) in the atmospheric and splash zones, either pin-point rusting or rusting initiated by coating abrasion. The System 13 buoy also had rust in the submerged zone, but in this portion of the System 13C buoy rust occurred only on the square of steel exposed by wire brushing to test the cathodic protection system. The 13C buoy had been struck by a ship that bent the cathodic protection unit, but this damaged neither the coating nor the cathodic protection system.

Figure 17. System 13C buoy before removal of fouling.

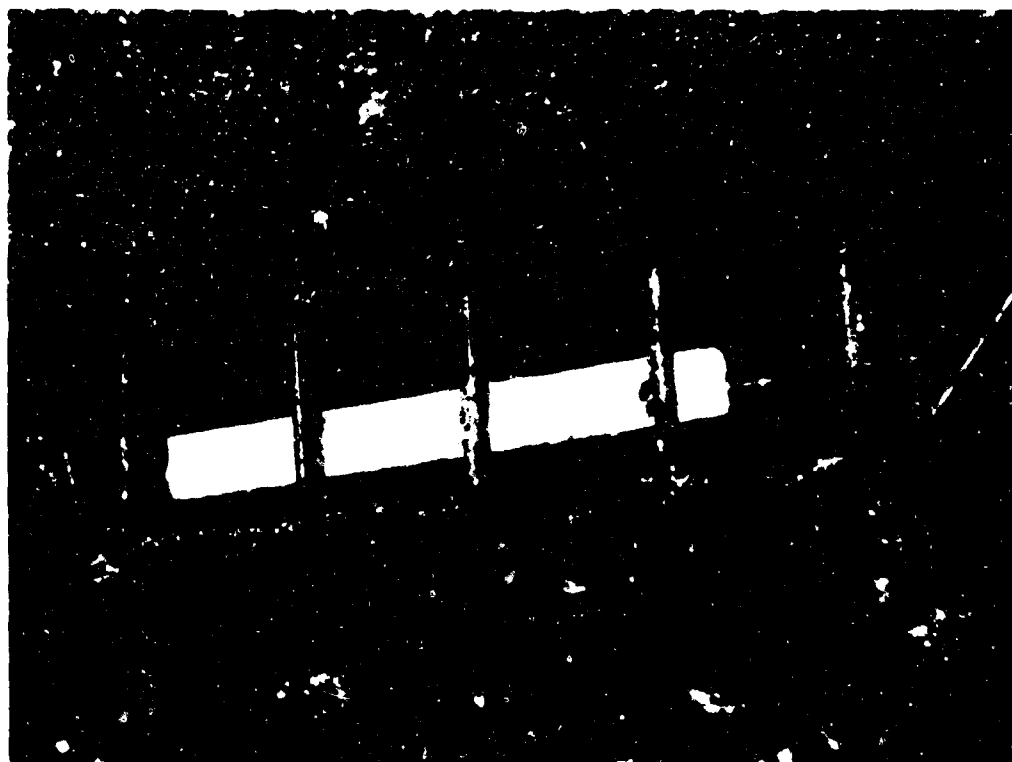
Figure 18. Zinc anode of System 7C after 132 days.

Consequently, the cathodic protection system on the System 7C buoy was again modified. The magnesium anode was replaced with a zinc anode, and the remote ground cable was joined directly to the steel pipe supporting the zinc anode. With this arrangement, current does not pass through the control head, which now serves only as a securing bracket. Although both anodes were of the same general size, the zinc anodes weigh about 145 pounds — approximately double that of the magnesium anodes. Immediately after the modified buoy was returned to the water, its potential was -840 mv. When checked 29 days later, buoy potential was -980 mv. After 51 days, it was -900 mv with a naval vessel secured to the buoy. At the time of the present inspection (132 days after the modification), buoy potential was -930 mv. The condition of the anode at this time is shown in Figure 18.
